**U.S. ENVIRONMENTAL PROTECTION AGENCY  
REGION 5**

**CWA OVERSIGHT INSPECTION REPORT  
ILLINOIS**

<b>Inspection facility</b>	Hollis Shafer Swine Farm 785 North Taylor Lane Astoria, Illinois 61501
<b>NPDES permit status</b>	No permit
<b>IEPA inspection date</b>	04/16/12
<b>EPA inspection date</b>	09/14/12

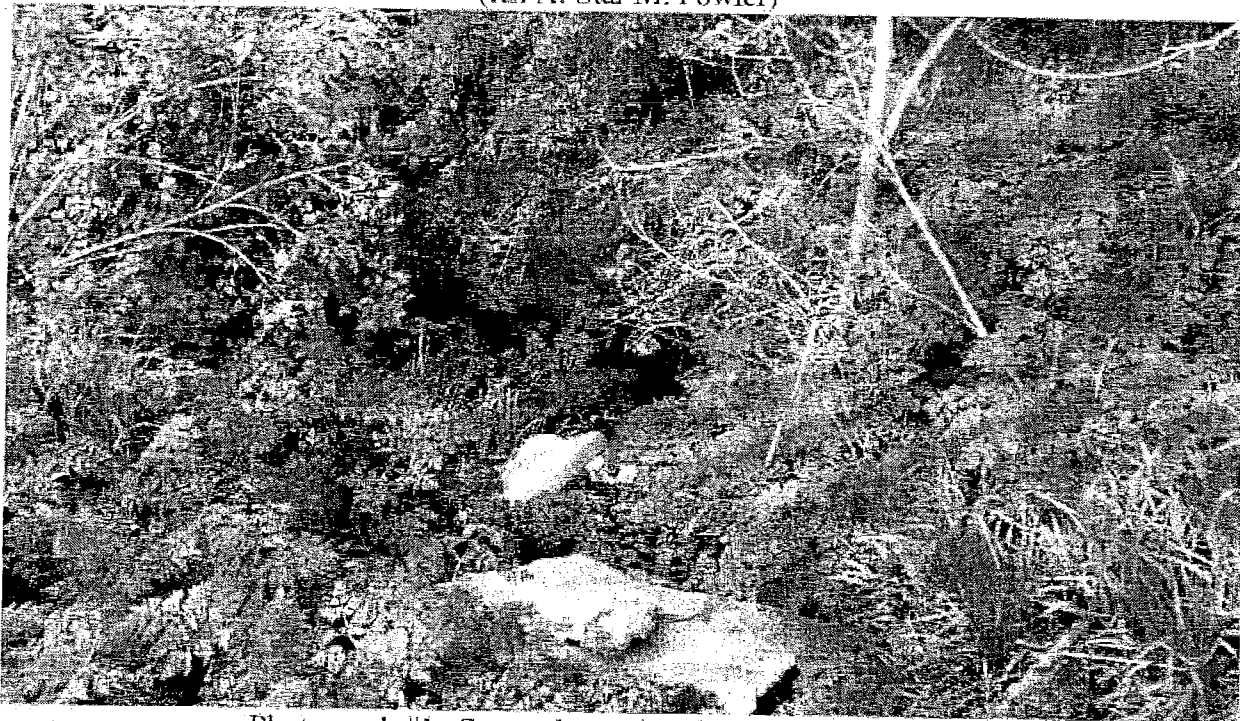
The stream located to the west of the facility on the west side of Taylor Lane was observed. The liquid in the stream had a dark coloration.

Photograph #1. Stream located to the west of the facility.

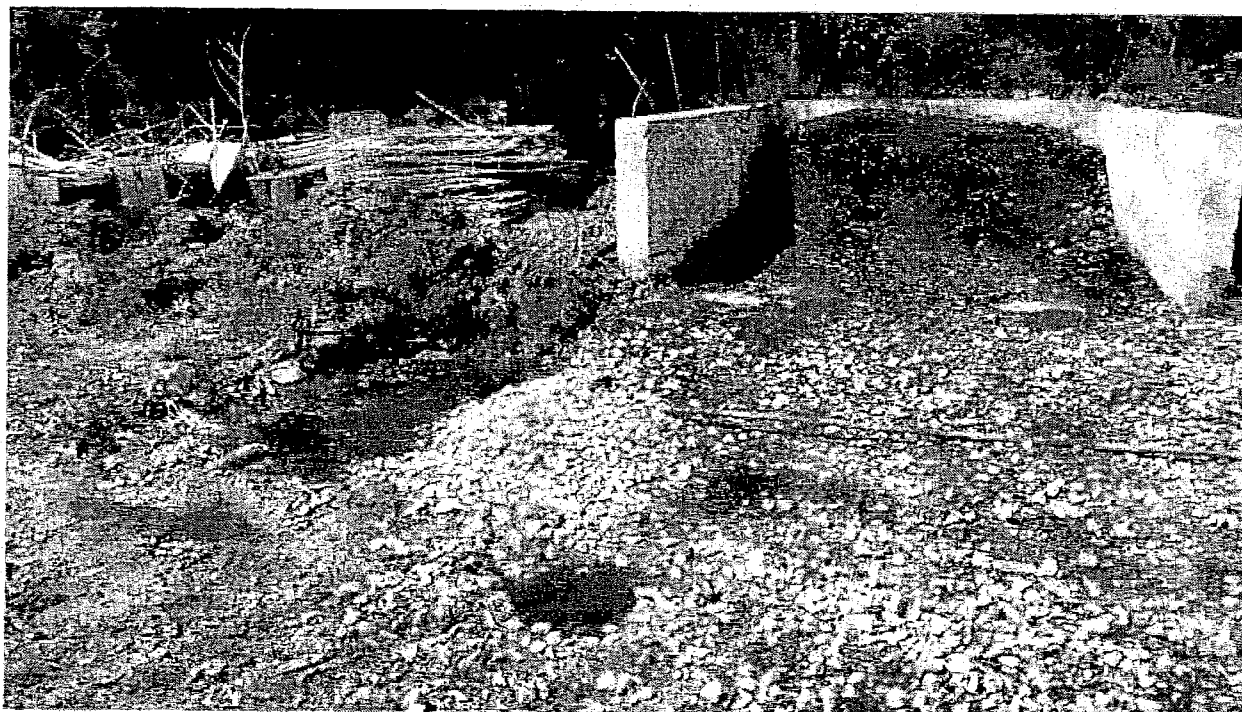
This compost unit was observed with leachate pooling near the composter. There did not appear to be enough carbon source (mulch), and the carbon source being used appeared to have a high moisture content. There was no thermometer or temperature readings being taken. See Photographs #8-#11.

Photograph #10. Leachate from the compost unit is being released.

- d. Proper cover should be established for both mortality compost units.
  - e. Proper carbon source should be used; this will help maintain proper moisture content. A few examples of proper carbon sources are: coarse sawmill sawdust, shredded corn stalks, chopped straw, coarse-ground corn cobs.

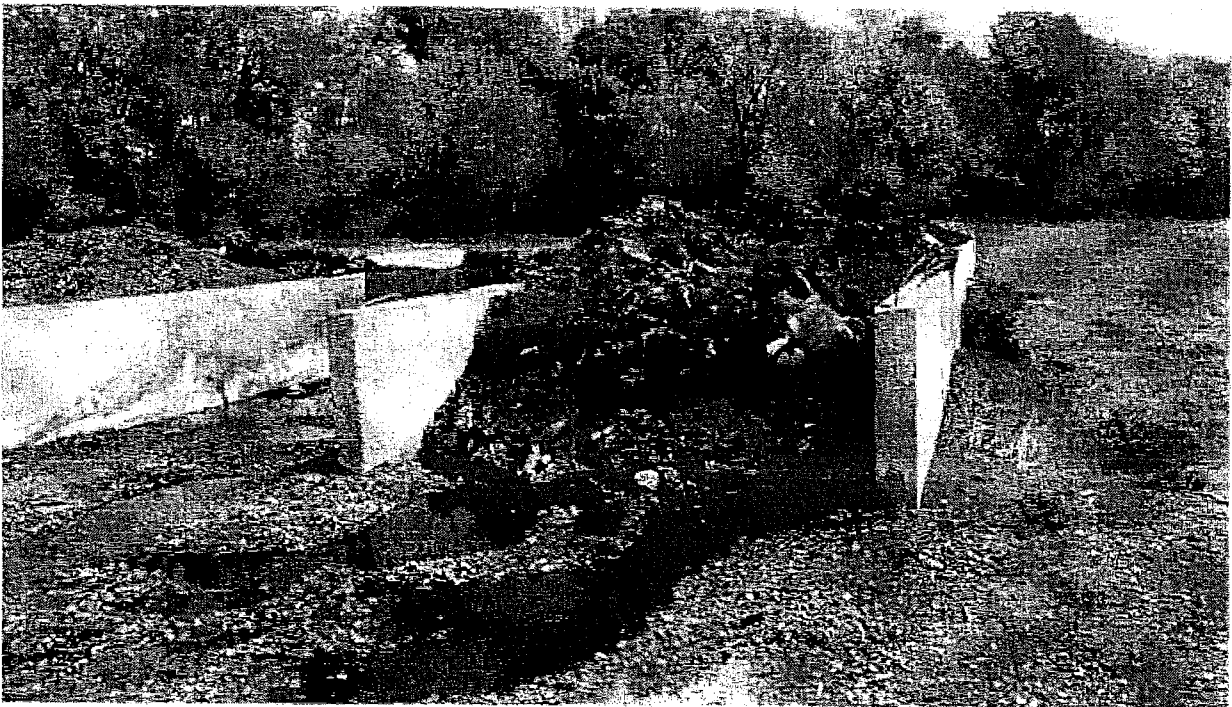
Photograph #12. North Mortality Compost Unit. Sow carcasses exposed. South Side of composter view is east.

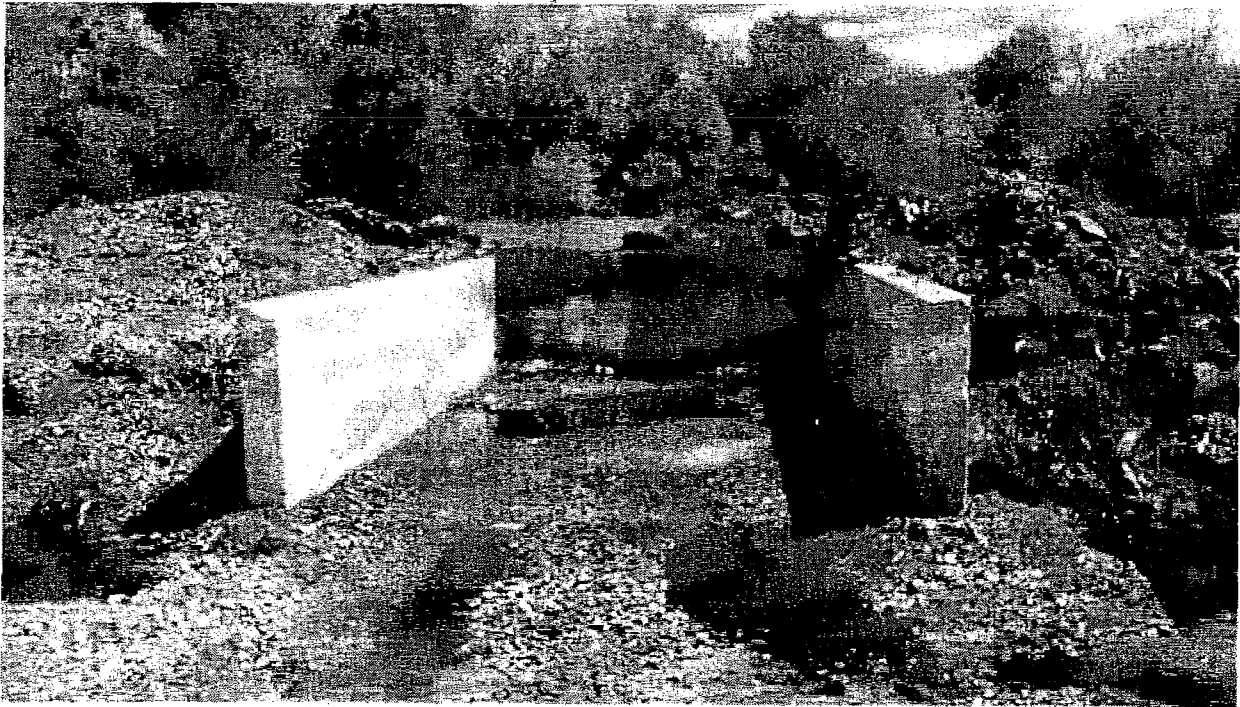
Very dark colored and odorous leachate was observed being released from both side of this mortality compost unit. There were multiple bones observed not being properly covered. There were also sow carcasses exposed. See Photographs #13-#18.

Photograph #13. Leachate from the North Mortality Compost Unit is being released.

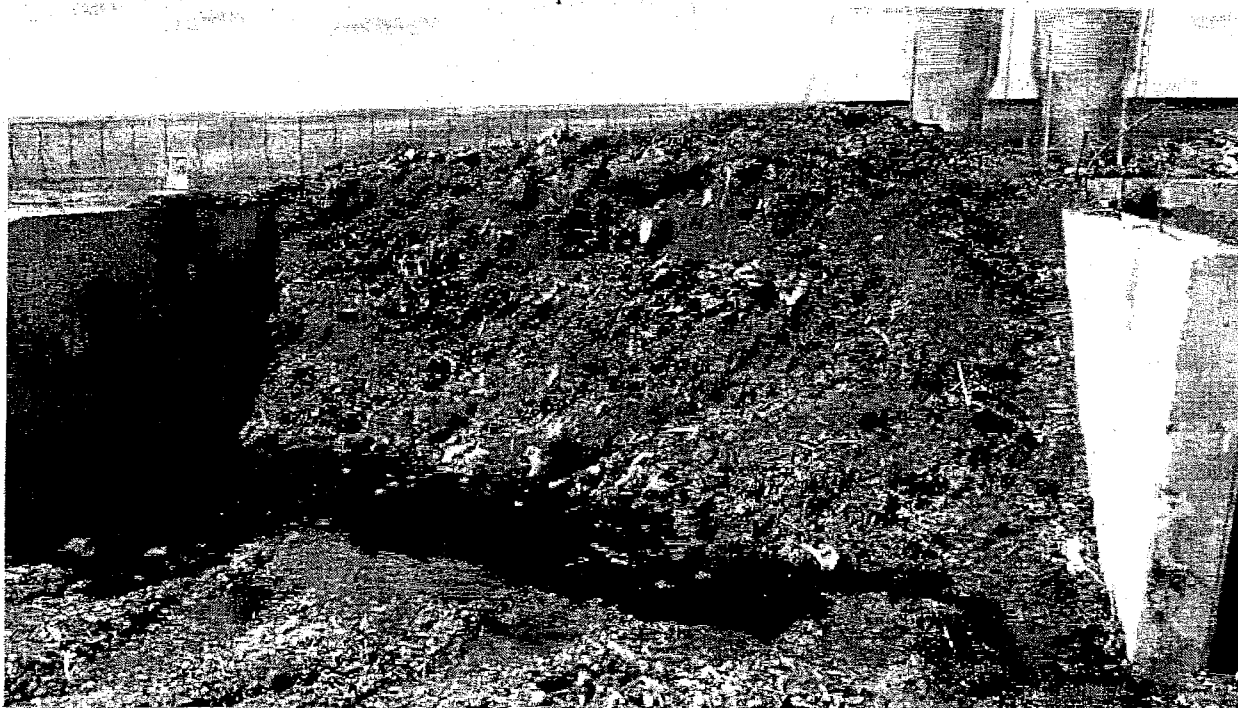
Photograph #17. The southeast bay of the north compost unit. Multiple bones are exposed. The leachate is being drained out of the compost unit.

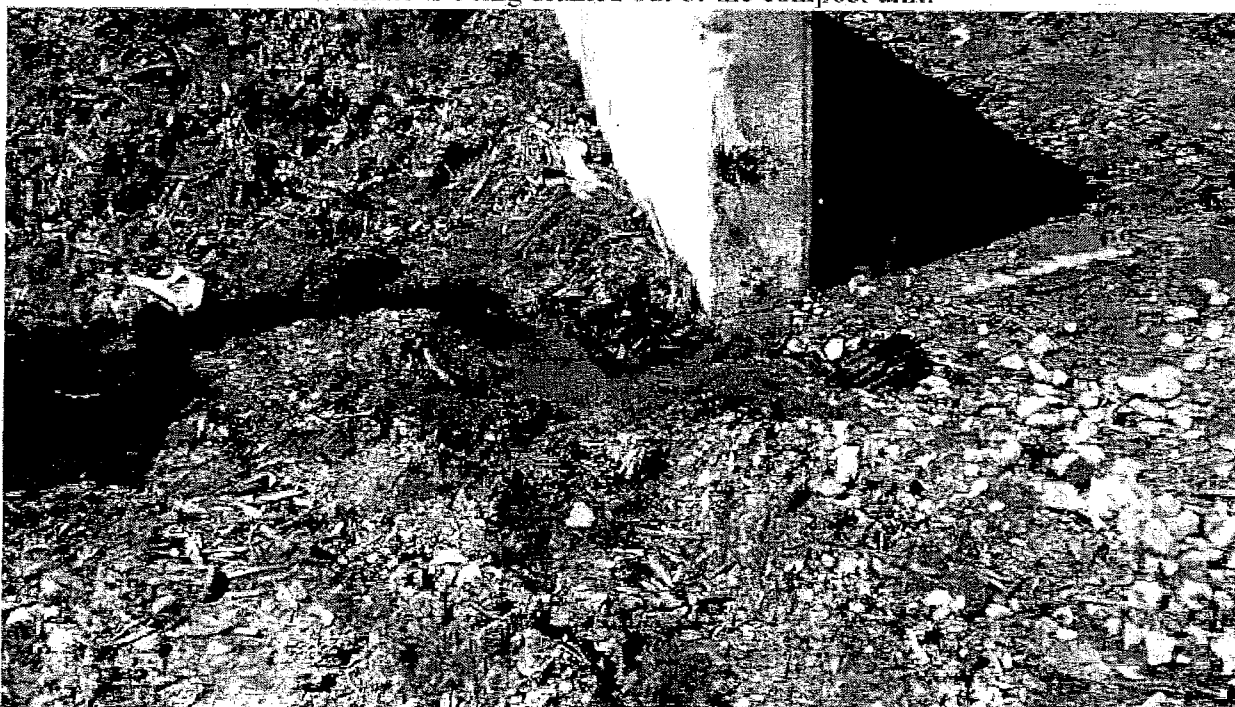
Mr. Cooper had recently installed a tile drainage line on the east side of the compost unit for the two east bays. This tile drains the leachate from the east bays and releases the liquid approximately 100 feet east underground into the adjacent field. During the inspection the outlet for the tile was not observed.

Photograph #18. The drainage tile on the east side of the North Mortality Compost Unit. This tile is draining the leachate from the mortality compost unit to the east.

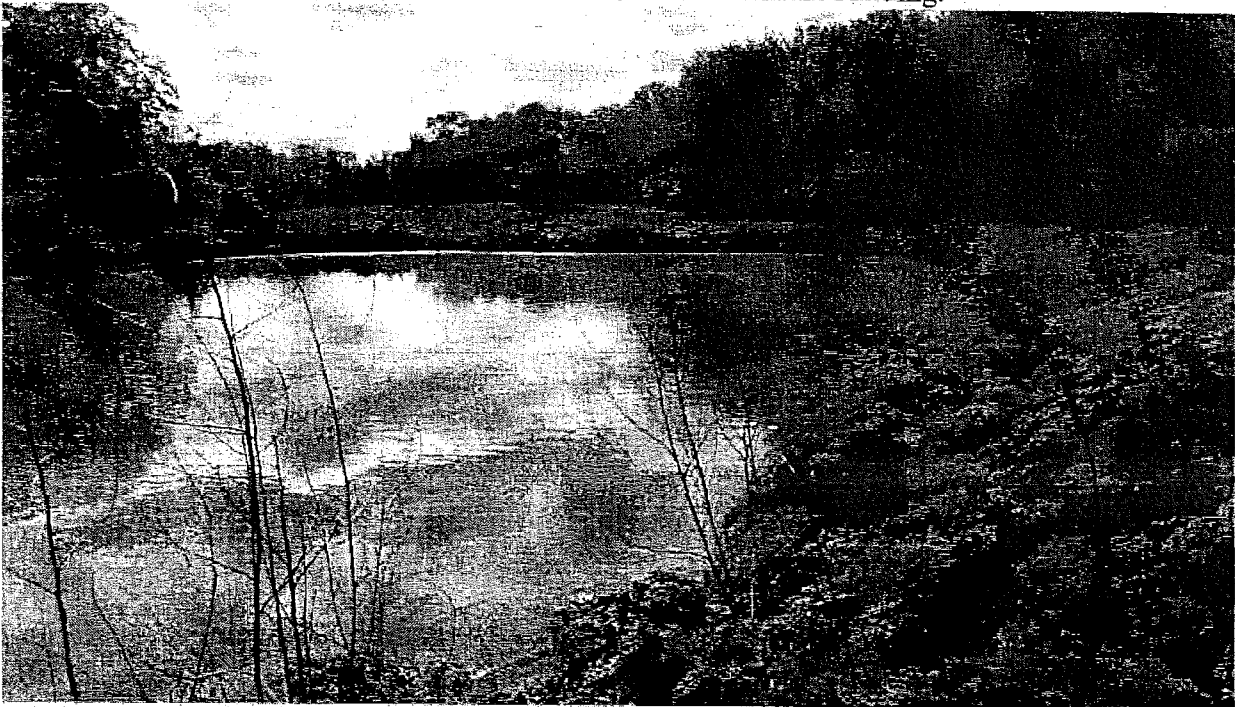
Photograph #20. Livestock Lagoon located on the south side of the facility.  
Liquid is a red color.

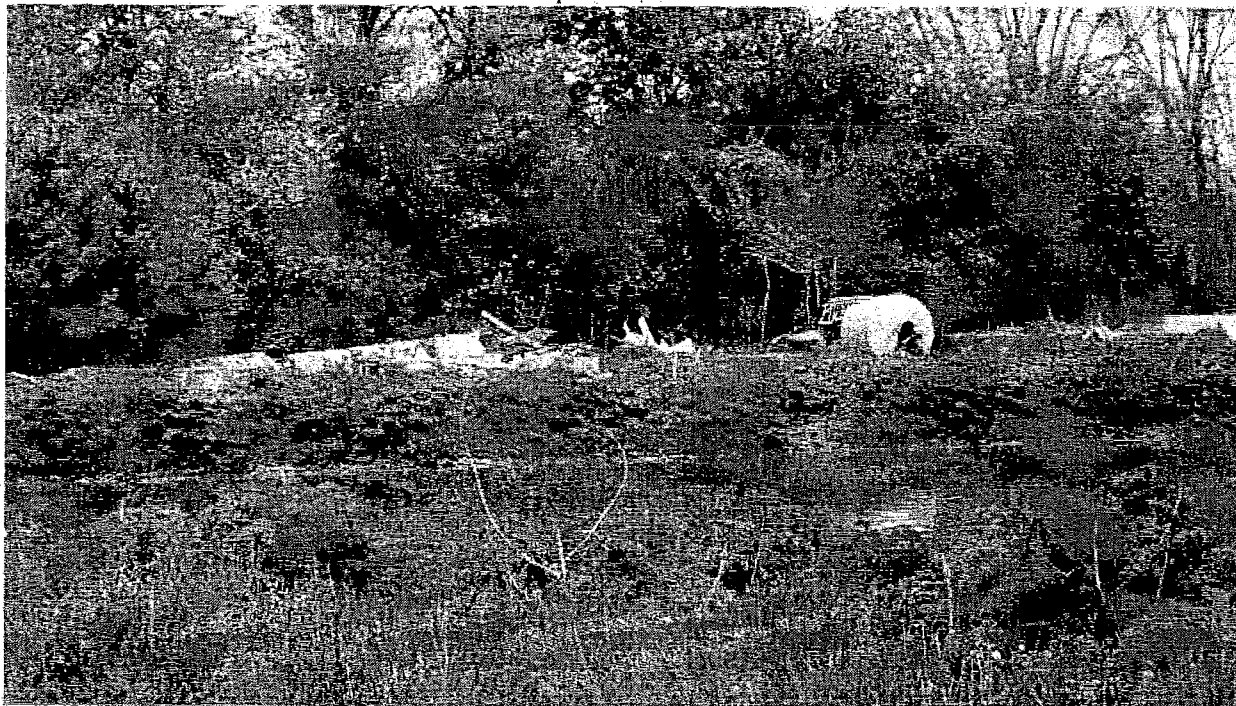
Photograph #21. East side of Livestock Lagoon, freeboard approximately 1.5 feet.  
There is debris near the wood line,

- b. Liquid manure should be removed to attain at all times a minimum of 2 feet of freeboard.
  - c. The integrity of the berms should be properly evaluated, with any found problems with the berms properly addressed.

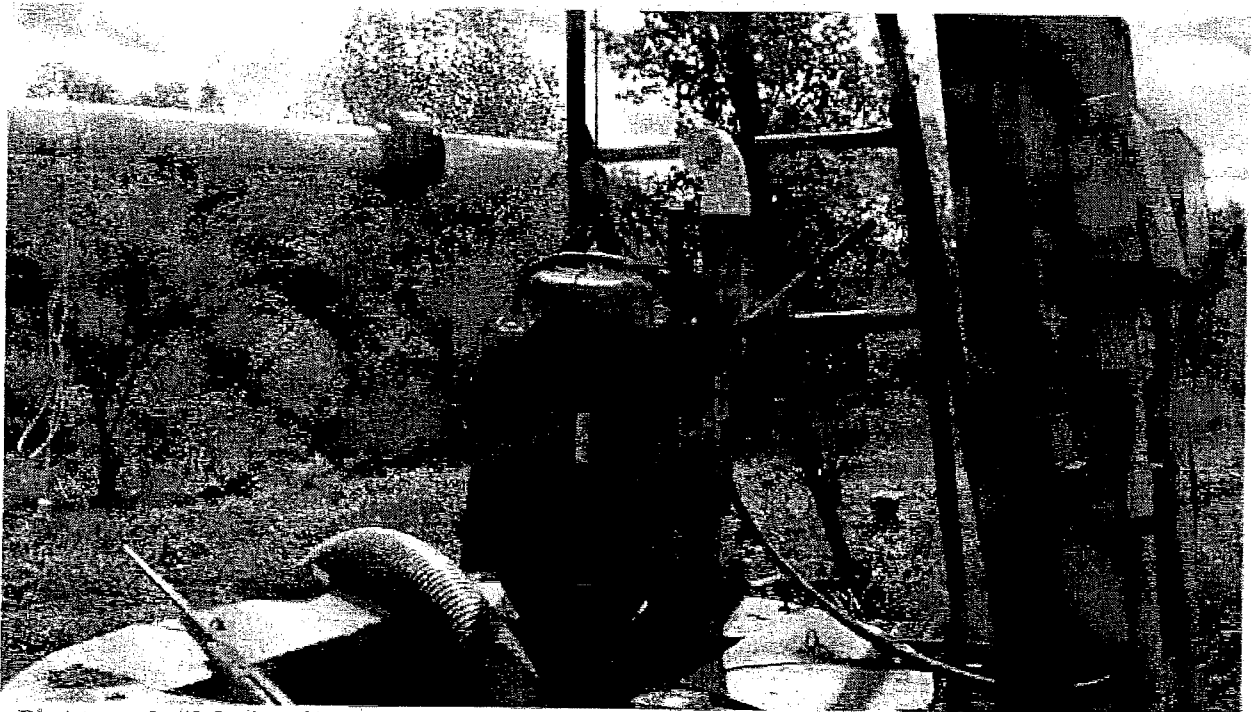
Mr. Cooper explained that the centrifugal 10 hp pump broke approximately one month ago. Cook AL Electric Motors was hired the next day to replace the pump motor, in doing so the impeller was damaged. The impeller has remained damaged since and the pump station is not working.

Photograph #26. South Side Pump Station, centrifugal 10 hp pump. The piping for the pump discharge is not hooked up to the transfer pipeline.

3. South Side Pump Station is not working due to the impeller being damaged. This lead to manure overflowing and becoming released from the pump station. This pump station should be fixed immediately. All the manure solids near the pump station from the liquid manure releases should be removed and properly land applied.

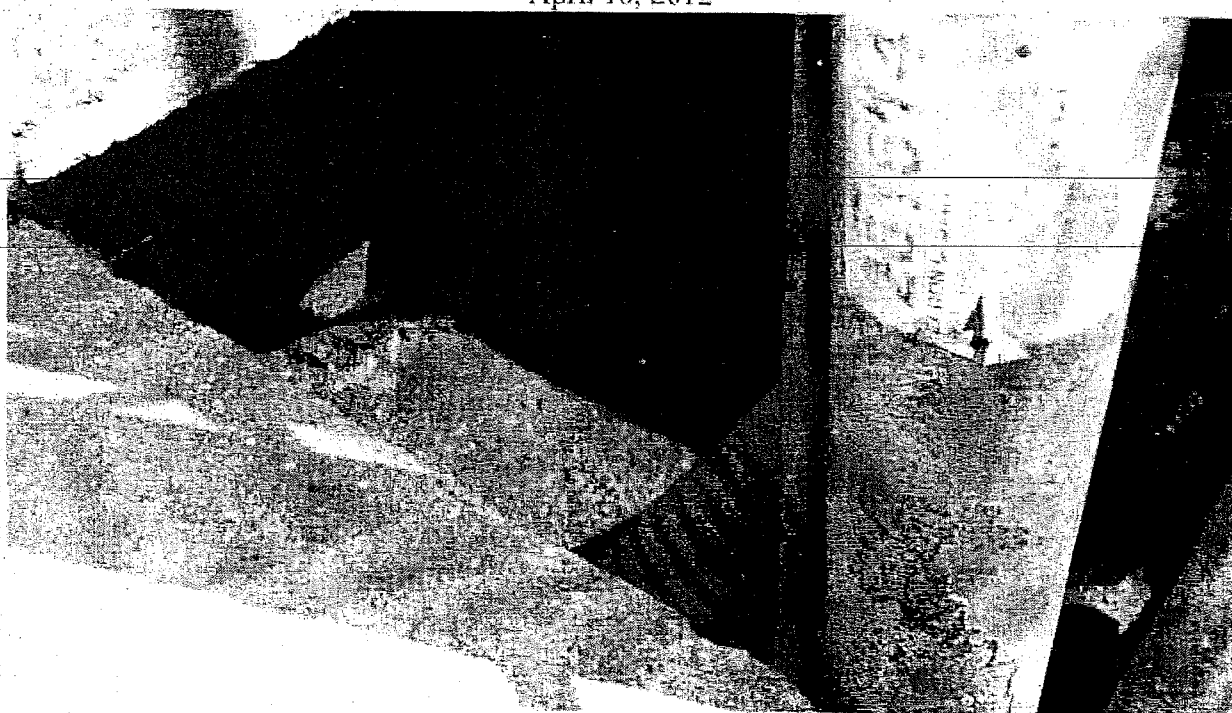
Photograph #27. Inside the South Side Pump Station approximately 2-3 feet of freeboard.

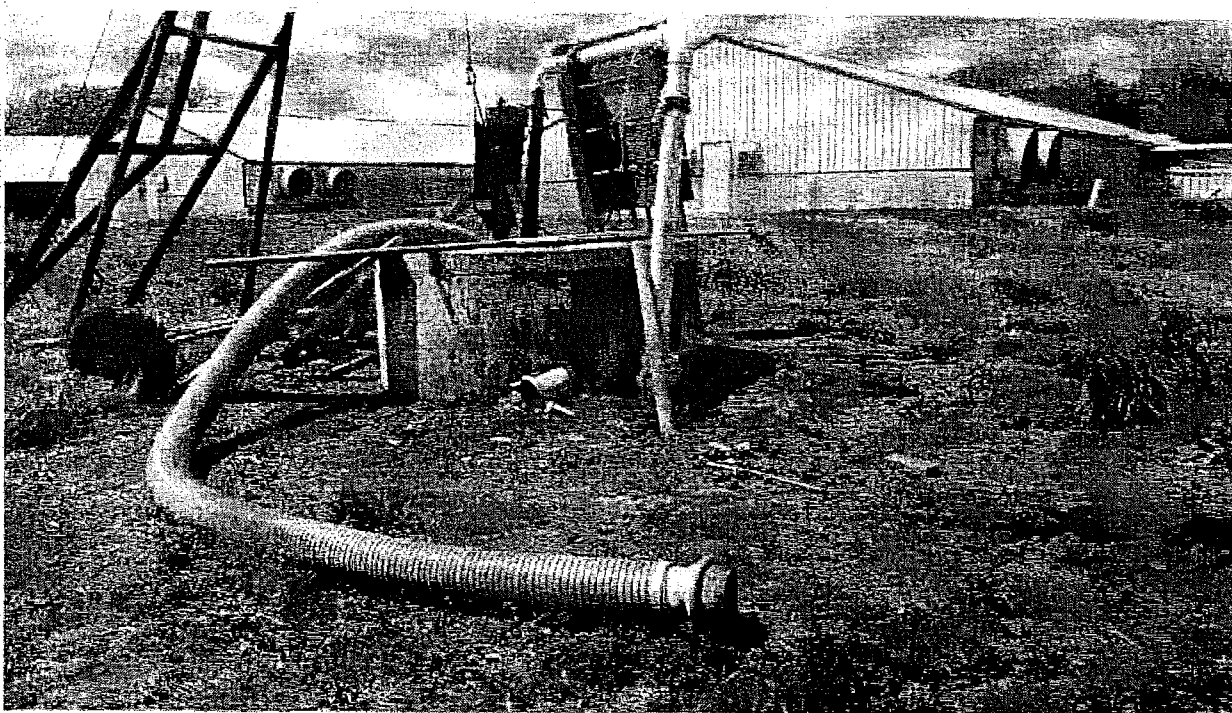
Photograph #28. Manure solids are observed surrounding the South Side Pump Station.

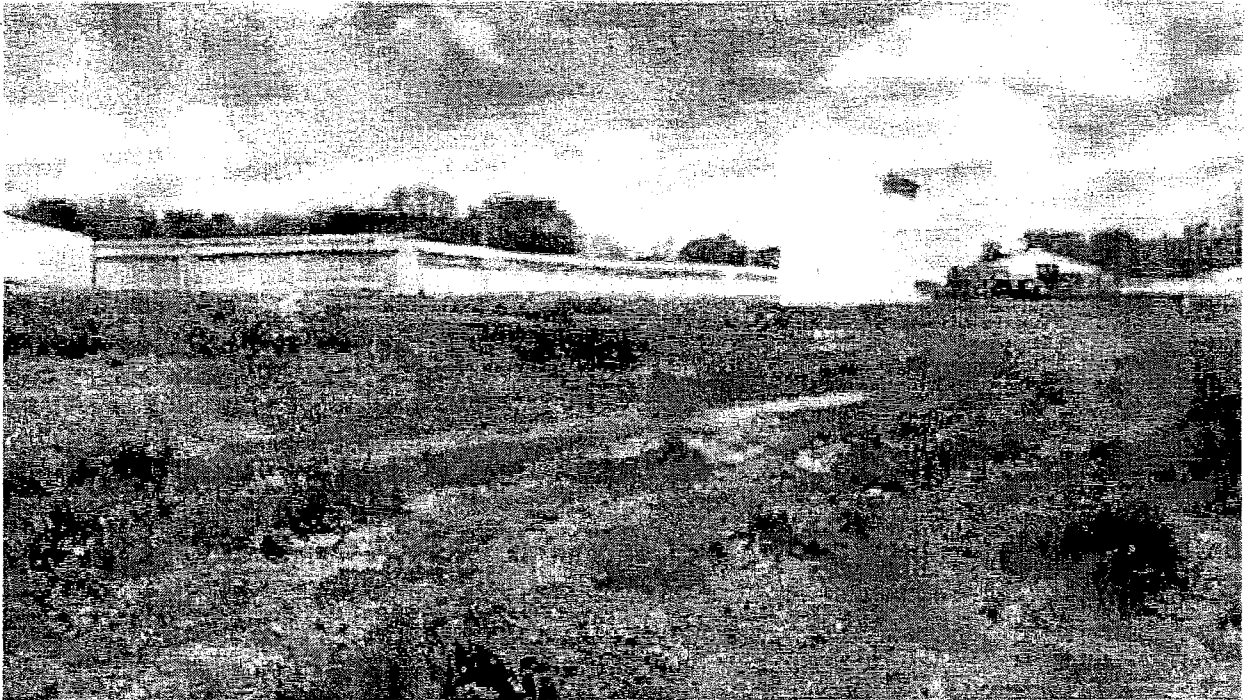
Photograph #29. The manure released from the South Side Pump Station drains to the northeast of the pump station. View of manure solids from past releases from the South Side Pump Station and manure collection system main pipeline clean-outs.

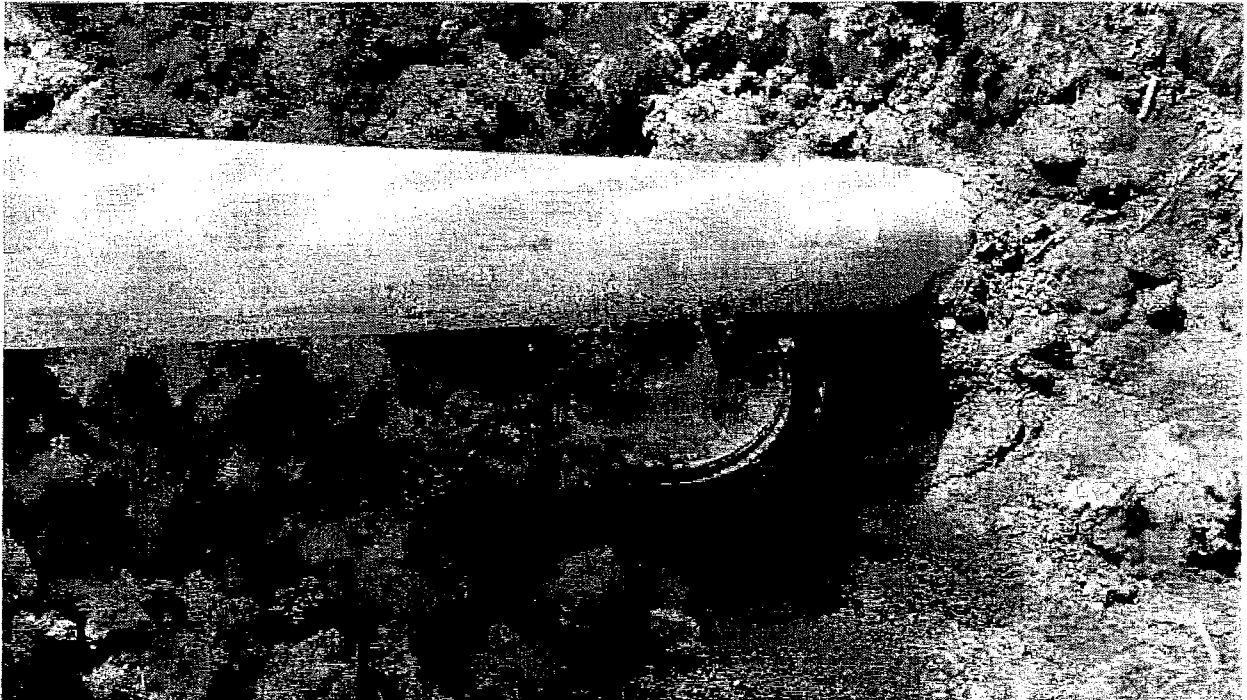
Photograph #30. Clean-out for Building H entering main pipeline for manure collection system. This clean-out had a recent manure release that contributed to the manure solids found in Photograph #29.

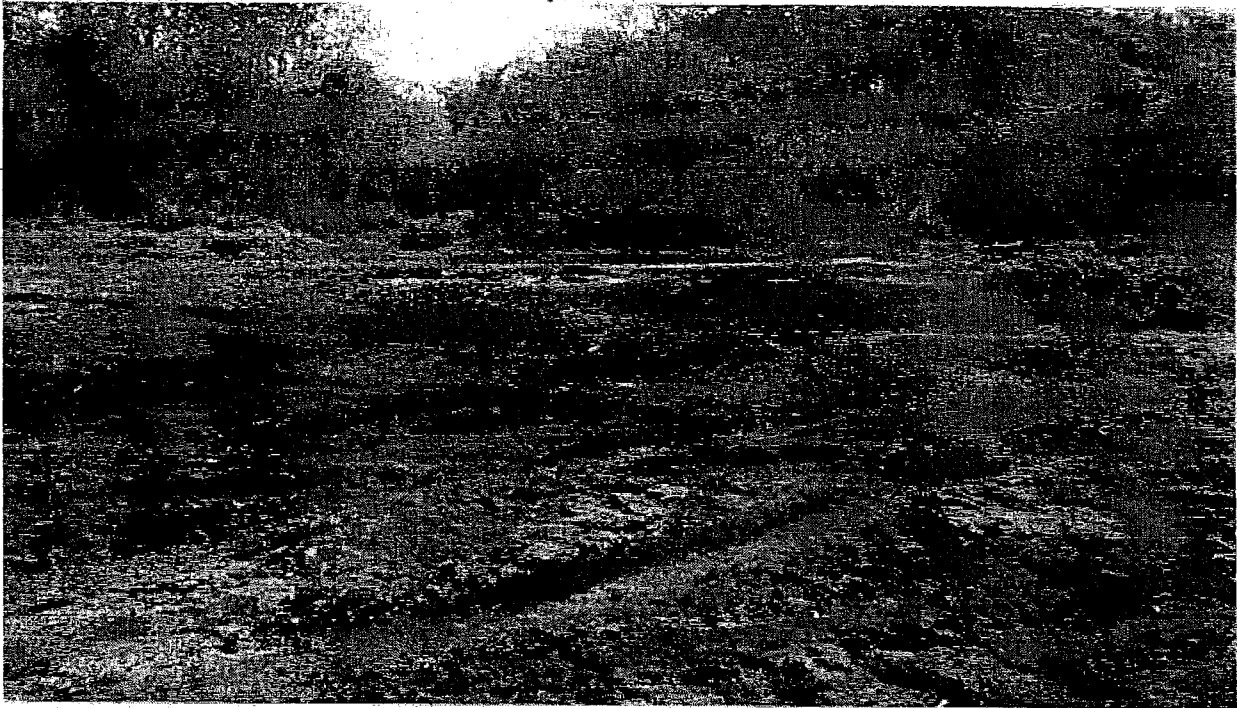
Photograph #31. Recent manure release from Building H clean-out pipe being plugged, located to the east of the building. View is east.

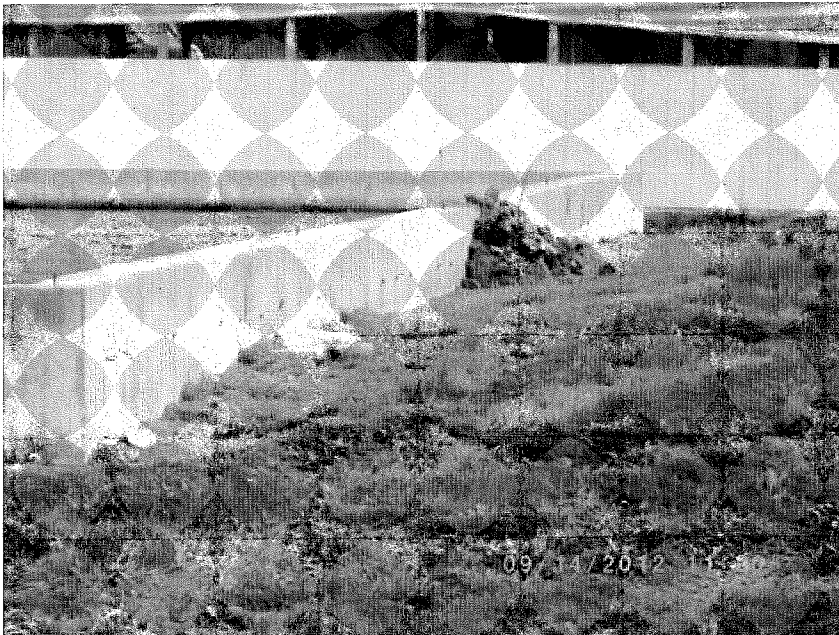
EPA observed some dirt piled up against the south wall of the Concrete Pit. Mr. Wittig stated that he discovered cracks in the concrete wall of the pit and manure was leaking out onto the ground. According to Mr. Wittig, the dirt piled up against the wall prevented the leaking manure from flowing into the yard and being transported with storm water to the intermittent unnamed tributary of Sugar Creek.

IMGP1576: Mr. Wittig stated that he piled up dirt against the wall of the Concrete Pit because of a crack in the pit's wall. Otherwise, manure leaked out onto the ground.

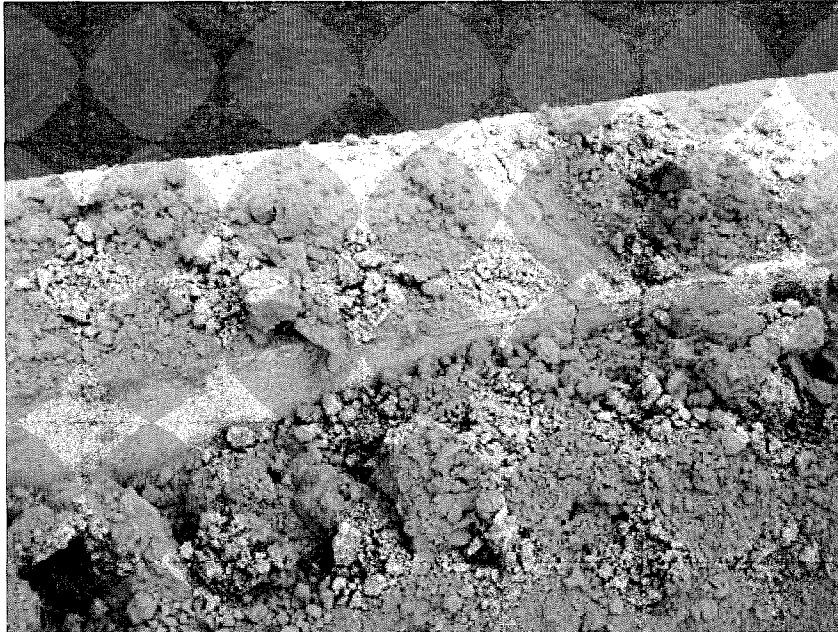
IMGP1578: Crack in wall of Concrete Pit causing a manure leak from pit.  
 Location: South wall of Concrete Pit  
 Facing: Down  
 Date/Time: 09/14/12 11:22 A.M.

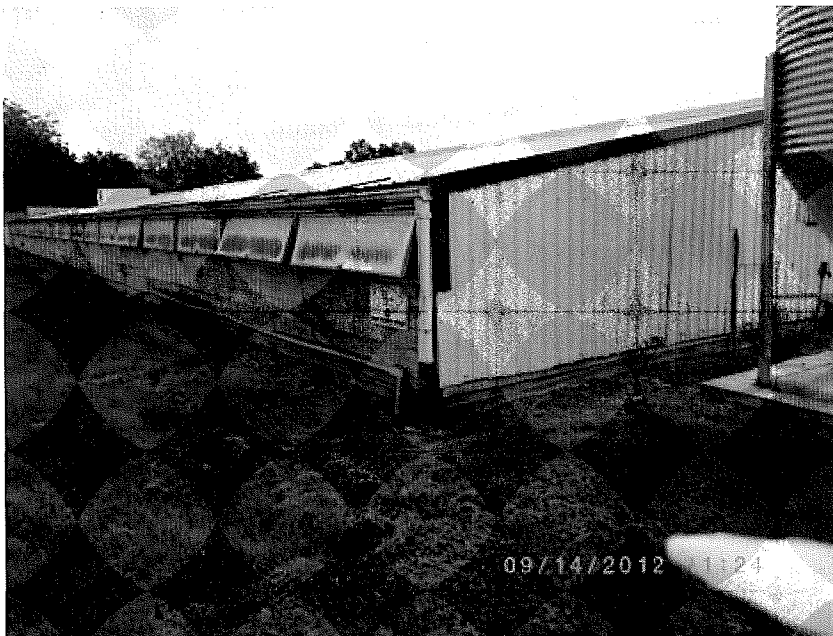
IMGP1579: Gestation Building G has a 2' deep pit and inner concrete wall. Downspout discharges roof storm water to ground at corner, causing wood decay.  
 Location: Northwest corner of Gestation Building G  
 Facing: Southeast  
 Date/Time: 09/14/12 11:24 A.M.

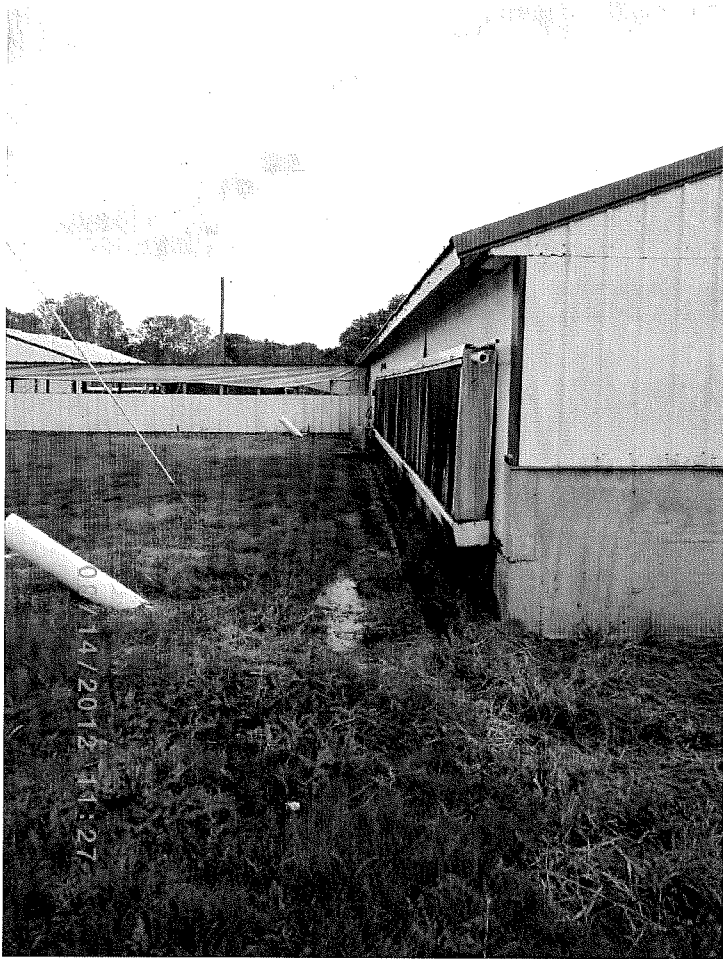
Gestation Buildings J and K and the South Farrowing Building had cooling cells attached to the windows of the building. The cooling cells forced the outside air to flow through water and the process of evaporation cooled the air before it entered the barn. A leak in the water line allows clean water to pool on the ground beneath the cells. The water has channelized and flows to the west toward a crop field.

IMGP1583: Cooling cells leak water onto the ground underneath the units.  
Location: Northwest corner of Gestation Building J  
Facing: East  
Date/Time: 09/14/12 11:27 A.M.

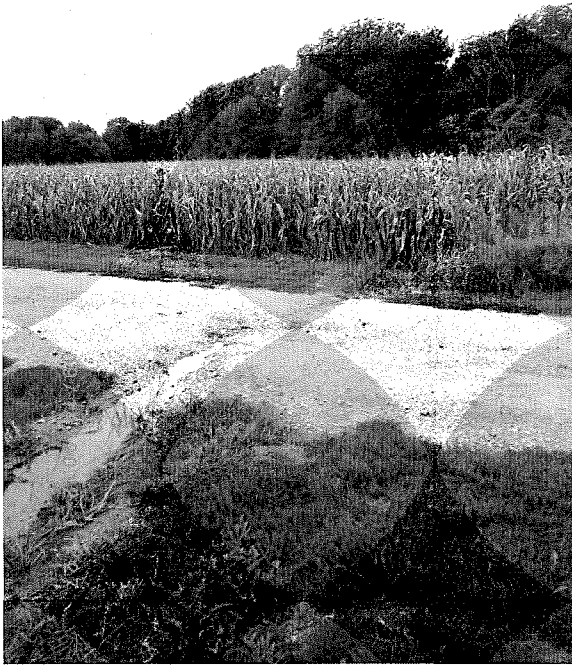
IMGP1584: Storm water pathway from the northwest corner of Gestation Building J to the crop field to the west. Water in pathway is from cooling cells for the barn.  
 Location: Northwest corner of Gestation Building J  
 Facing: West  
 Date/Time: 09/14/12 11:27 A.M.

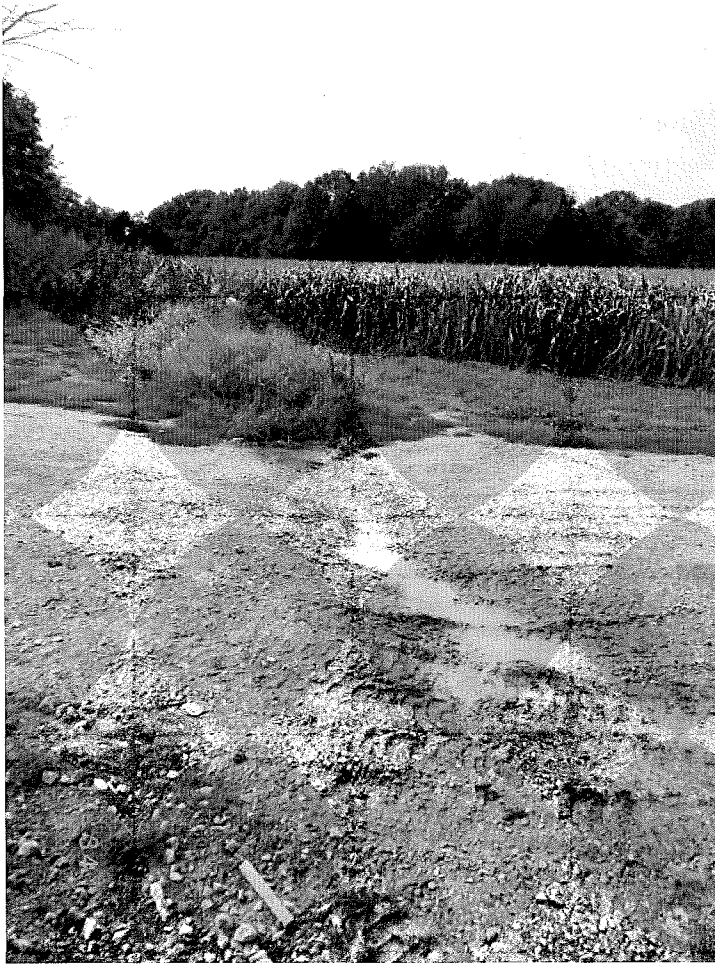
IMGP1588: Storm water pathway leading from the South Farrowing Building to the crop field to the west. Water in pathway is from cooling cell water which leaks onto the ground.

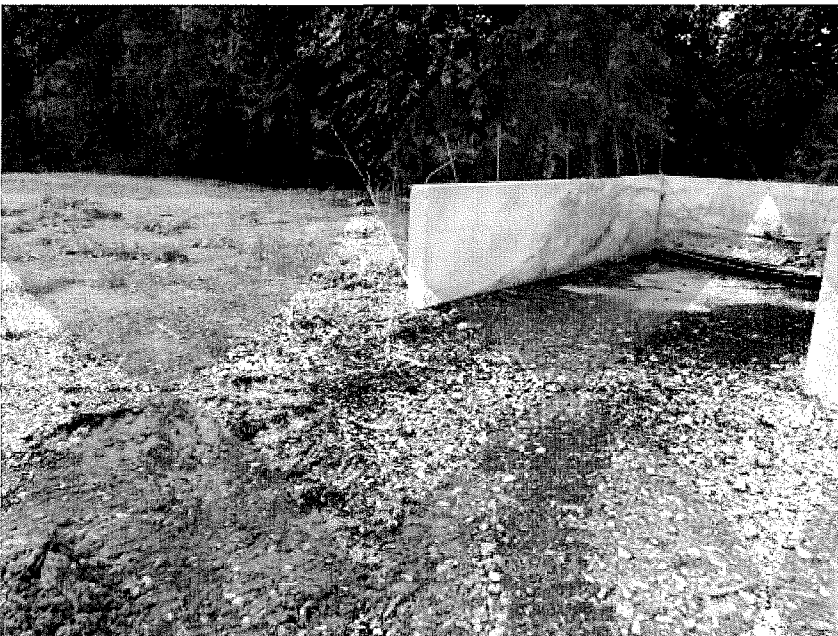
IMGP1590: South Compost Unit has two bays. One was empty. EPA noted bones on the ground and exposed animal carcasses in the compost bins.  
 Location: South Compost Unit  
 Facing: Southeast  
 Date/Time: 09/14/12 11:38 A.M.

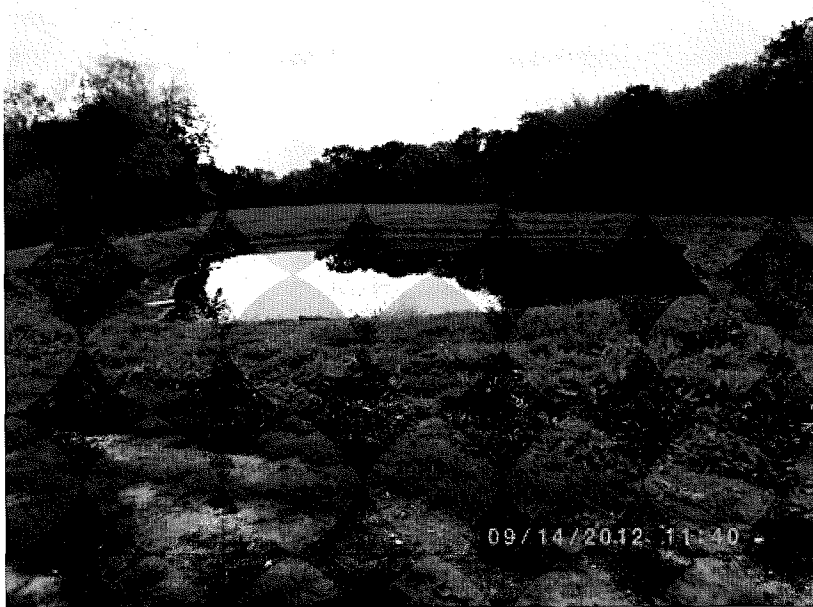
IMGP1591: Emergency Pond is used for emergency storage. It is not lined but was dug into clay. There was approximately 4' of freeboard in the pond on the day of the inspection. The berm vegetation was at a reasonable height and there was no woody growth in the berms. There was no depth gauge in the Emergency Pond.

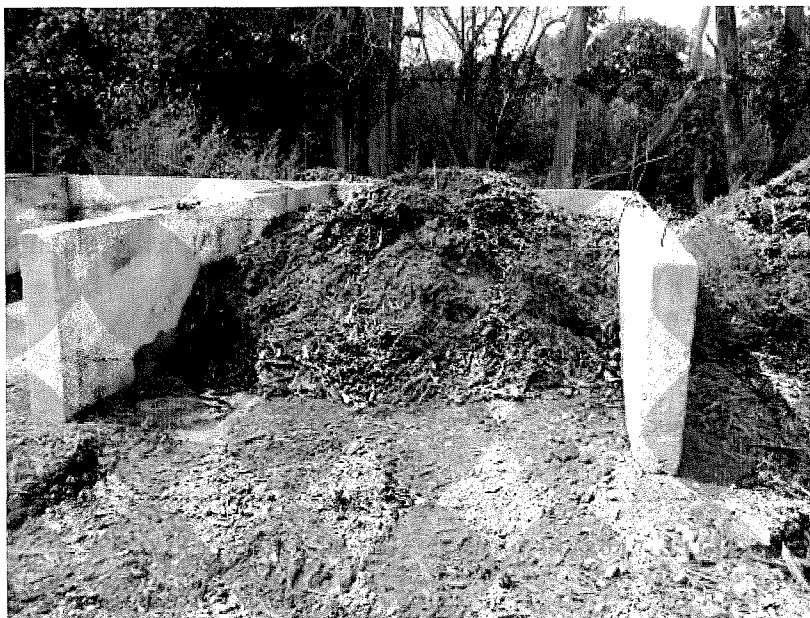
IMGP1592: EPA noted bones on the ground and exposed animal carcasses in the South Compost Unit. Some of the compost was spilled over the back wall of the unit.

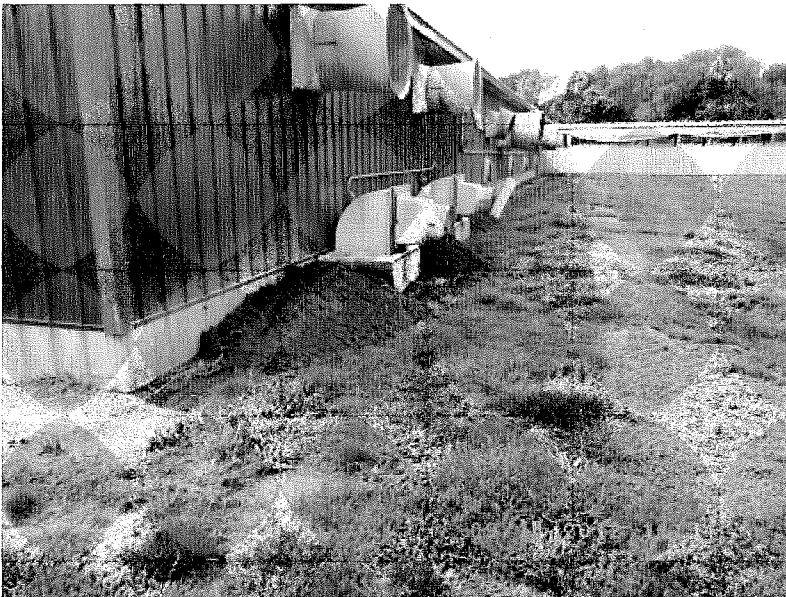
EPA began walking north along the east side of the facility. EPA noticed that there was dirt mounded up along the north wall of the South Gestation Building near its northeast corner. Mr. Wittig stated that during the installation of the pit fan housing, cracks in the pit walls of the pit had developed. The dirt was used to prevent the manure from leaking out onto the ground.

IMGP1596: Dirt mounded up along building is where there are cracks in the concrete that occurred when the pit fan housing was installed.  
 Location: Northeast corner of South Gestation Building  
 Facing: West  
 Date/Time: 09/14/12 11:54 A.M.

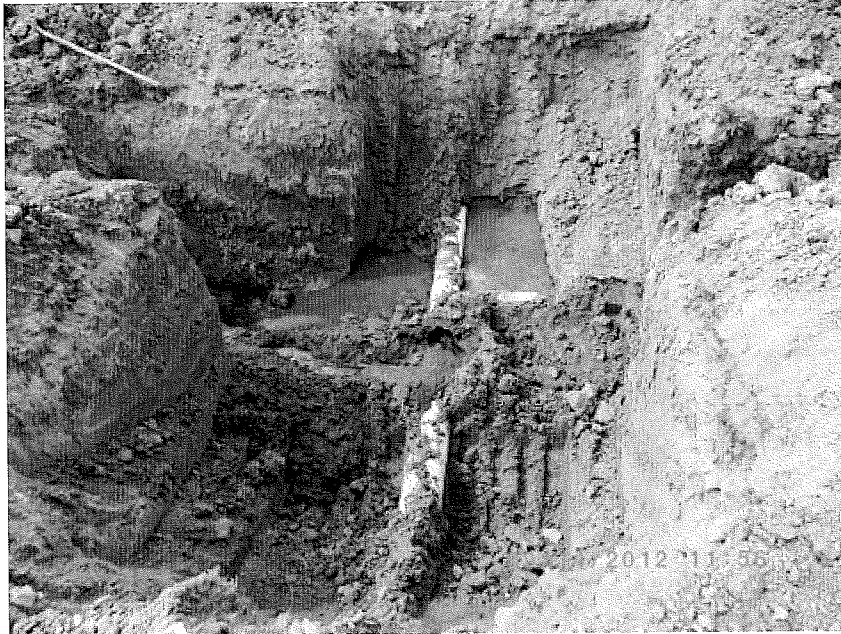
On the east side of Gestation Buildings J and K, a hole had been dug into the ground to expose the manure piping. Mr. Wittig stated that while removing a plug in one of the manure pipes, they had inadvertently broken the pipe. The facility was in the process of repairing the broken piping. Although there was manure in the bottom of the hole, EPA did not observe any evidence that the manure had discharged to the ground around the hole.

IMGP1597: Broken manure pipe between Gestation Building J and K.  
Location: East of Gestation Building J and K  
Facing: Down  
Date/Time: 09/14/12 11:56 A.M.

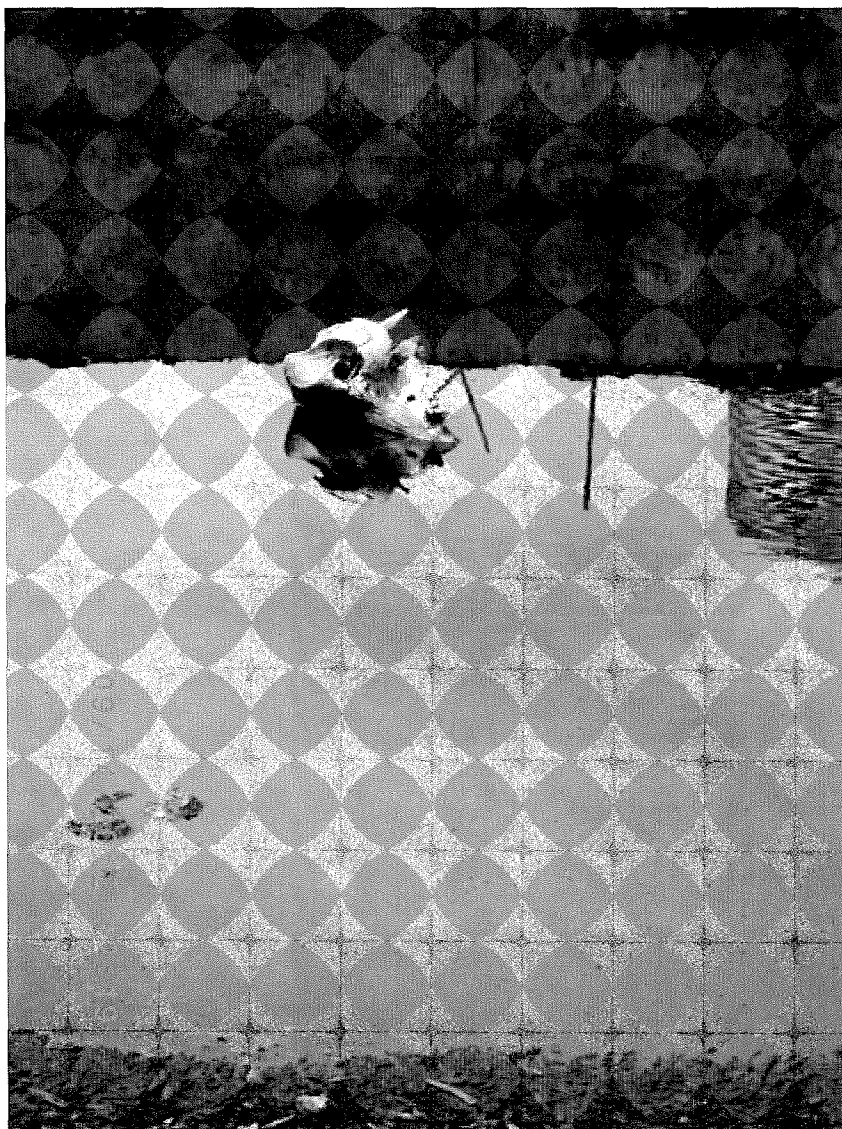
IMGP1610: Skull from mortality in standing liquid in east bins of the North Compost Unit.
